MOBILE INFRARED SCANNING - A HIGH-TECH, ACCURATE ALTERNATIVE TO TRADITIONAL BRIDGE INSPECTION METHODS

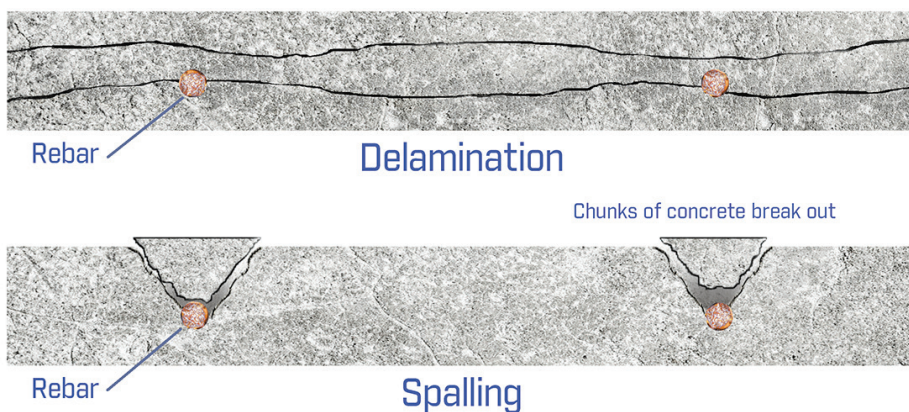
Finding concrete delamination typically involves a form of non-destructive testing (NDT) called acoustic chain drag inspection. The inspector drags a heavy chain across the bridge deck, listening for the distinctive hollow sound produced by delaminated areas. He can then use this data to create a delamination map of the bridge deck.

There are disadvantages to the chain drag method. Even though this type of inspection involves shutting down the lane under survey, inspectors are frequently required to work alongside open traffic lanes. The traffic noise makes it difficult to distinguish sounds the chain makes as it crosses delaminated concrete. In addition, the chain drag method relies heavily on the knowledge and experience of the inspector, making it subjective and potentially inaccurate. In fact, an FHWA study of deck delamination surveys concluded that the chain drag method did not consistently provide accurate results.

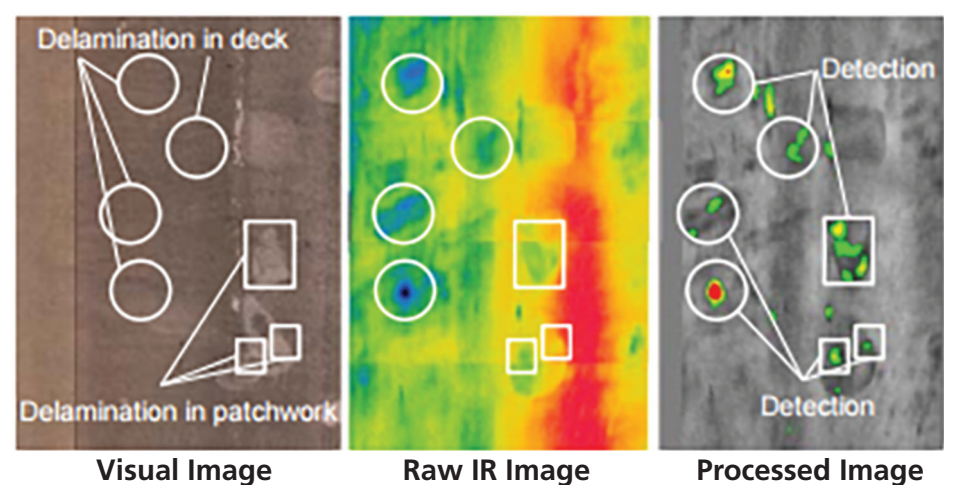
Visual, raw, and processed delamination images from IR survey of bridge deck Source: "Comparison of Infrared Cameras for Concrete Bridge Deck Scanning: - Vol.2 Field Test at Haymarket Bridge", December 2014, NEXCO-West USA, Inc

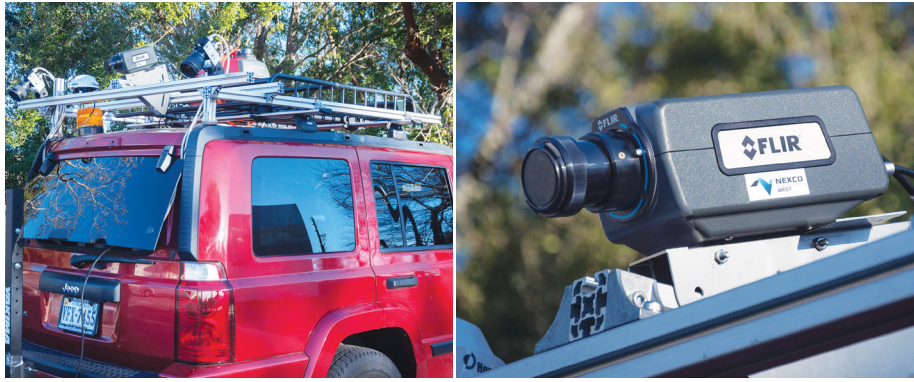
NEXCO-West's mobile survey setup

FLIR A6701sc camera used to create infrared delamination maps

The camera employed in NEXCO-West's scanning system is a FLIR A6701sc MWIR science camera. "We use the A6700 series camera because it can photograph high resolution thermal images while driving at high speed," explains Matsumoto. This camera's cooled Indium Antimonide detector offers integration times as fast as 0.48 μ s, allowing the team to record 640 x 512 pixel thermal images without any motion blur. Matsumoto says they typically set the camera for a 10Hz frame rate, which allows it to record a crisp thermal image every two meters at highway speed. The camera is connected to a laptop inside the vehicle that is running NEXCO-West's Infrared Bridge Assessment System (IrBAS) software, so the team can see real-time analysis and recognize potentially delaminated areas.

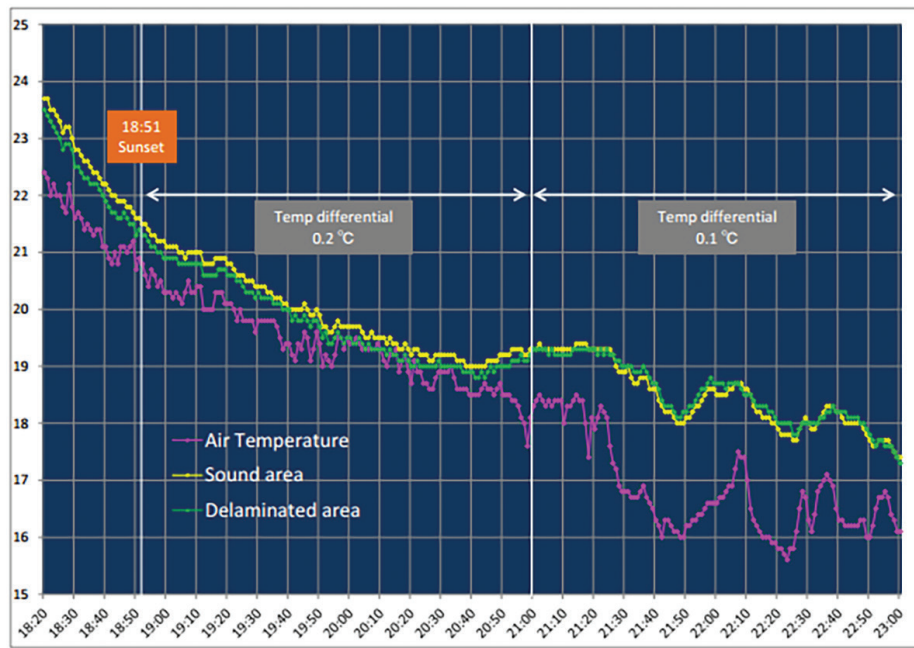
Example of temperature differential for sound and damaged concrete Source: "Comparison of Infrared Cameras for Concrete Bridge Deck Scanning: - Vol.2 Field Test at Haymarket Bridge", December 2014, NEXCO-West USA, Inc

Scans are usually performed during the day or within a few hours after sunset, when large temperature shifts can be observed. For example, concrete that heated up during the afternoon will begin to cool down after sunset, creating a measurable change in temperature. Most of the deck will heat or cool evenly, but delamination interrupts the conduction path. The temperature of the damaged concrete will

rise more rapidly during the day and fall faster at night, which is easily detected by the IR camera. Inspections are performed with a truck-mounted infrared camera while driving across the bridge at 50 miles per hour with traffic. Matsumoto says it only takes a few minutes for the infrared camera to record an entire scan of one lane of a one-mile long bridge.

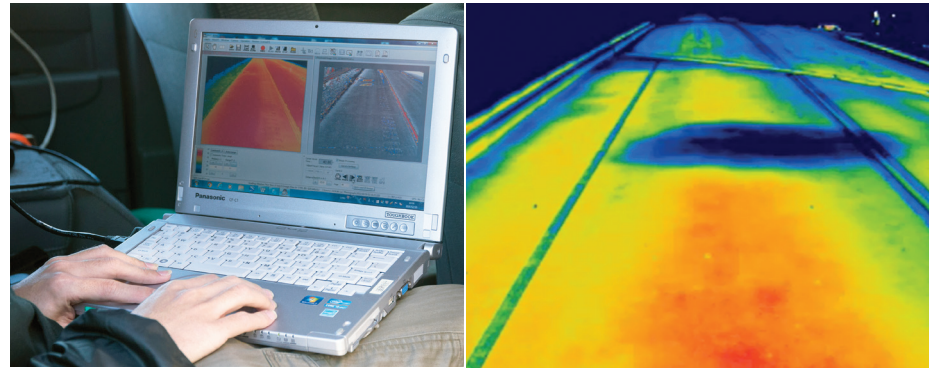
Laptop shows live-streaming infrared through NEXCO-West's IrBAS software

Thermal image used to create bridge deck deficiency map

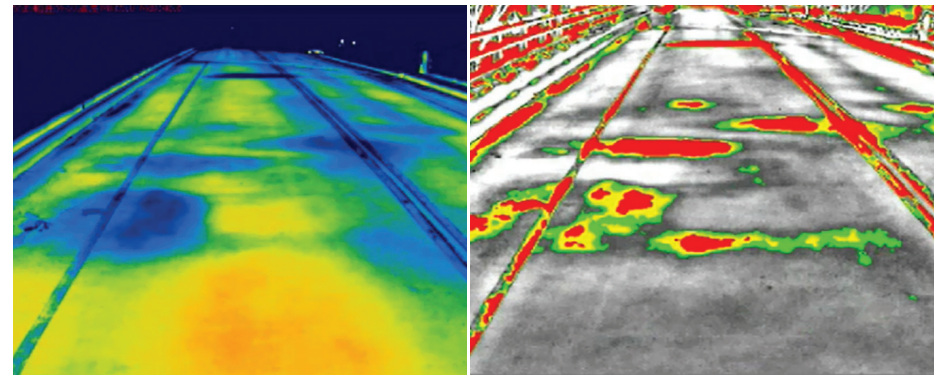
Thermal bridge scan (left) and IrBAS processed image used to create deck deficiency map (right)

Damage Rating		Temp. Distribution
Crack Location	Rating	
	Indication 	
	Caution 	
	Critical Emergent Action Required

1. Indication: Delamination is present within 4 cm of the concrete surface
2. Caution: Delamination is present within 2 cm of the concrete surface
3. Critical: Delamination is reaching the concrete surface Deck areas that rate Indication are considered satisfactory, while Caution areas require close monitoring. Any area rated as Critical requires immediate action.
