# USING AN INTRINSICALLY SAFE OPTICAL GAS IMAGING CAMERA TO MEASURE SEPARATOR SAND IN EXPLOSIVE ATMOSPHERES

At Noble Energy—an independent oil and natural gas exploration and production company—sand is both indispensable and detrimental. Accumulations of sand must be found quickly and removed before they cause damage to equipment. Most methods for finding the sand proved unreliable, until engineers realized the solution involved a high-tech tool they already had on hand.

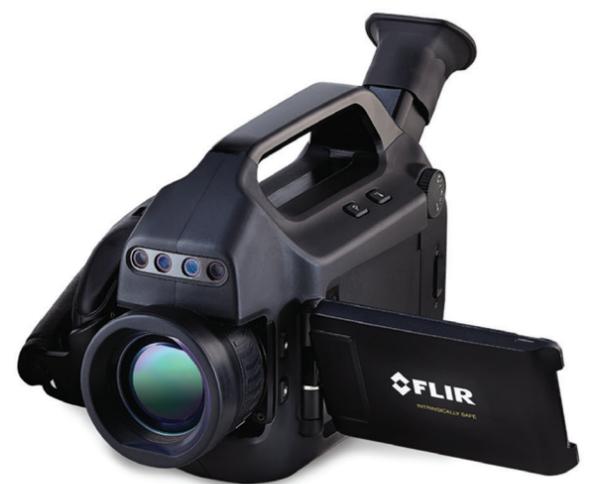
It takes only a few minutes to gather temperature set points on each tank. The rainbow palette in thermal images shows specific colors varying with temperature (see figure A & B). “High-contrast rainbow shows us the best temperature differences and our engineers like the range,” said Landon Hawkins, the engineer responsible for developing much of Noble Energy’s sand measurement method.

The FLIR GFx320 Intrinsically safe Optical Gas Imaging Camera

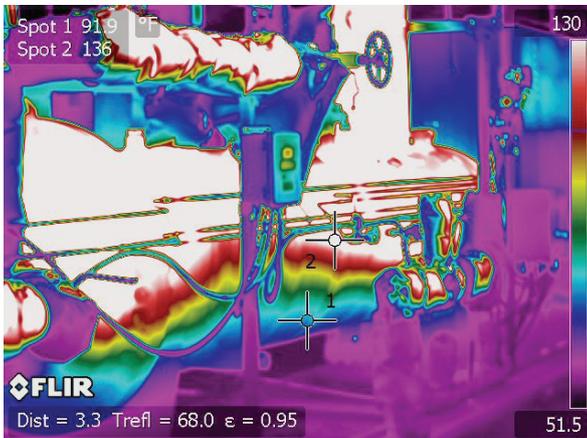
The FLIR GFx320 Intrinsically safe Optical Gas Imaging Camera

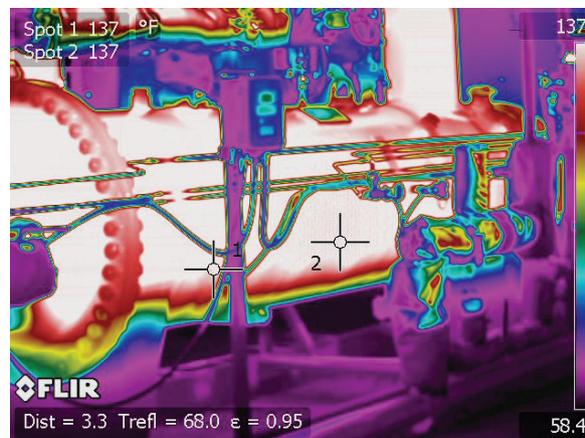
The FLIR GFx320 Intrinsically safe Optical Gas Imaging Camera

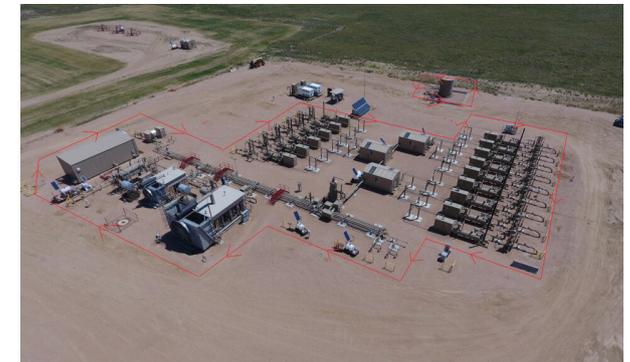
Separators at Noble Energy's Wells Ranch, Colorado site are located so close together that engineers need an intrinsically safe infrared camera to execute their sand measurement preventative maintenance program.

As is evident in figure C, rows of tightly sited separators limit access to each vessel. "Having an intrinsically safe camera has made a world of difference in doing this program," said Hess. "We are able to get into nooks and crannies where we weren't able to get before."
